Inspection Report

540 East 182nd Street Bronx NY

J&P Professional Property Inspections

Date: 8/16/2011	Time: 06:00 PM	Report ID:
Property: 540 East 182nd Street	Customer: Ms. Ingrid Alvarez	Real Estate Professional:
Bronx NY	· ·

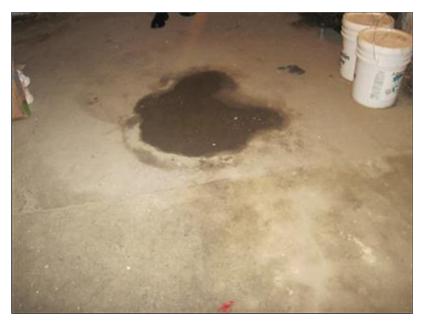
A. Picture 1 wet basement / water entry

Extensive moisture entry and damage (wet basement) was noted throughout basement at time of inspection. Mold and rot damage needs to be also addressed and repaired in the nea future. Recommend having licensed specialist evaluate and repair as needed. (Picture 1) (Picture 2) (Picture 3) (Picture 5) (Picture 6)

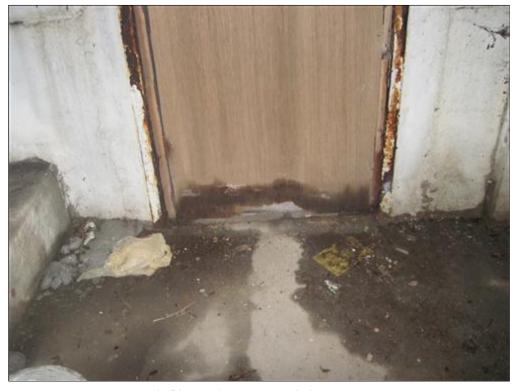
A. Picture 2 water entry in basement

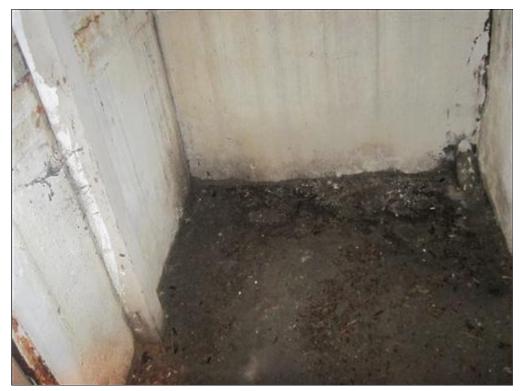
A. Picture 3 wet basement

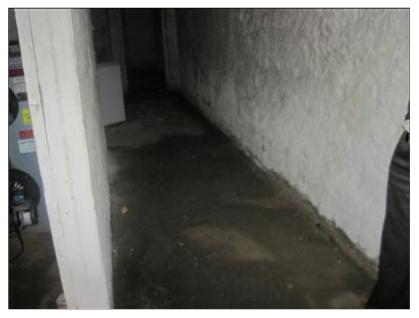
A. Picture 4 wet basement

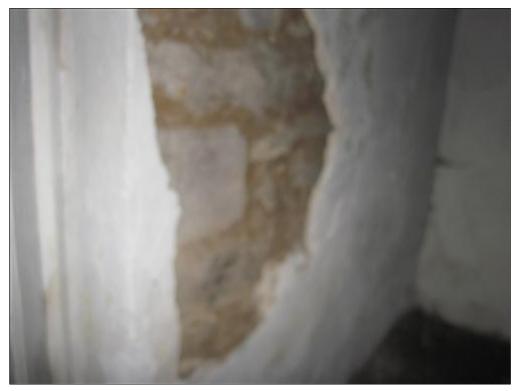
A. Picture 5 moisture damage

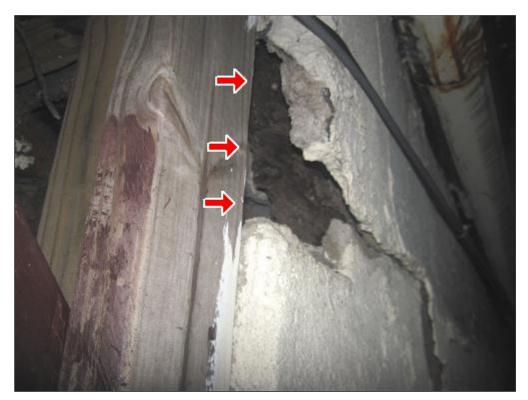
B. Picture 1 rot / termite damaged structural framing

Significant rot / moisture damage was noted on visible structural framing in basement at time of inspection. Most of structural framing was covered with finished surfaces. Structural repairs should be anticipated in future. Recommend having licensed further evaluate fully the basement and repair as needed.(Picture 1)(Picture 2)(Picture 3)(Picture 4)(Picture 5)

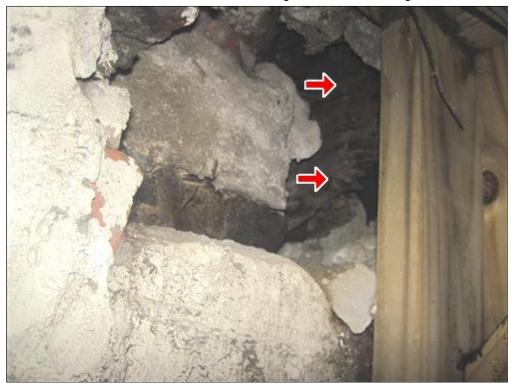
B. Picture 2 rot/termite damaged framing

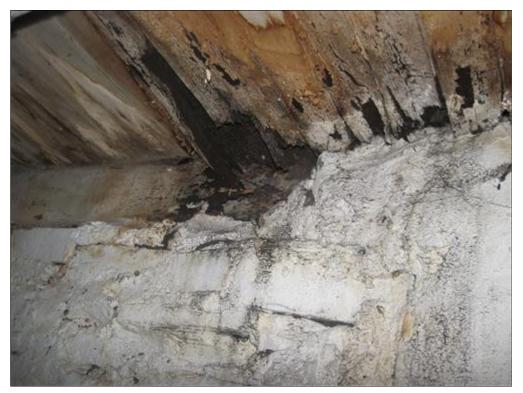
B. Picture 3 rot/termite damage

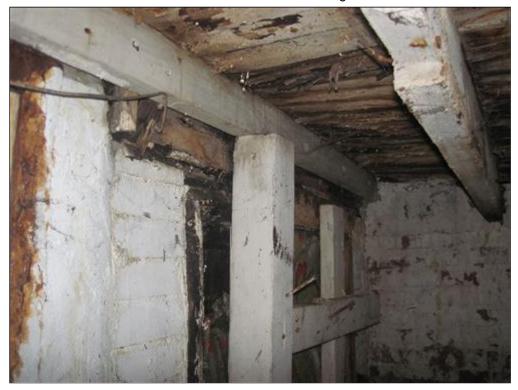
B. Picture 4 collapsing front entire area

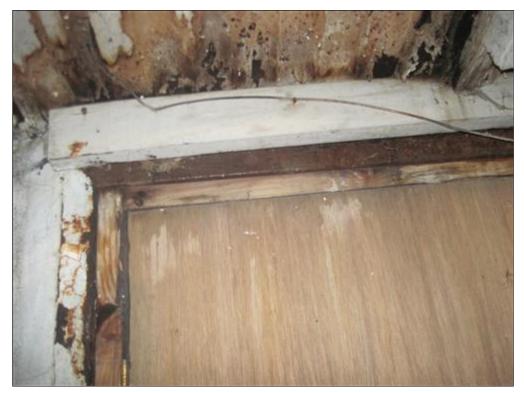
B. Picture 5 extensive damage

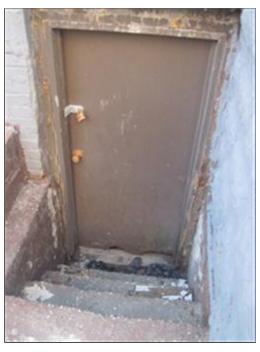
C. Picture 1 water damage

(1) There is a negative slope at the front, rear and sides of home and can cause or is contributing to water intrusion or deterioration. I recommend correcting landscape to drain water away from home.(Picture 1)(Picture 2)

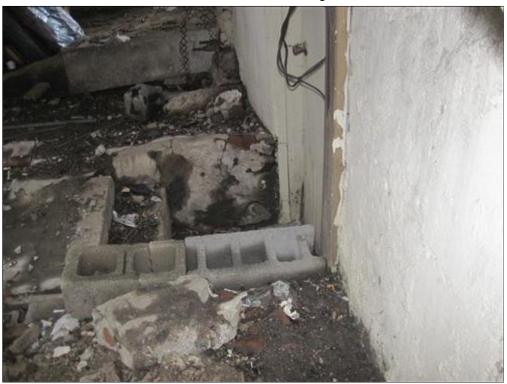
C. Picture 2 water entry / damage

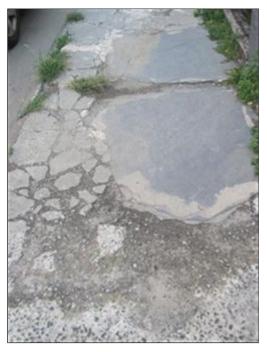
C. Picture 3 cracked / deteriorated sidewalks

(2) The concrete walkway and patio at the front of home has settlement cracks, deterioration, and damage. A qualified person should repair or replace as needed.(Picture 1)(Picture 2)(Picture 3)(Picture 4)

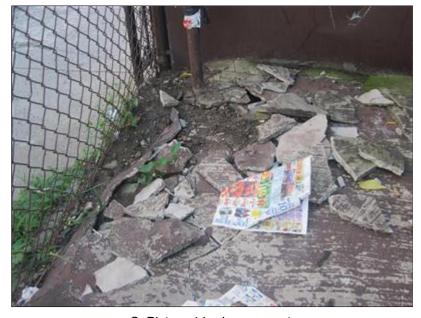
C. Picture 4 broken concrete

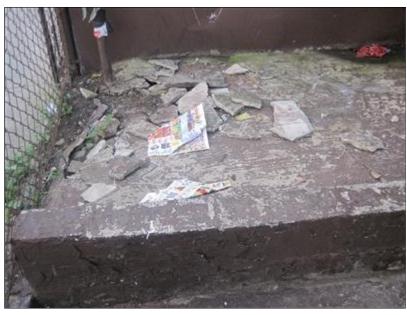
C. Picture 5 broken concrete / buried tank

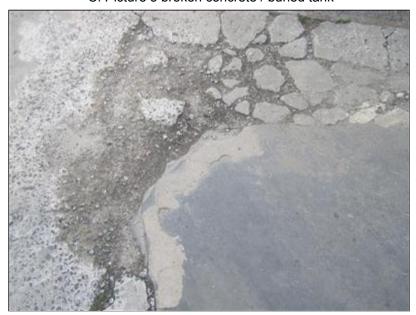
C. Picture 6 damaged sidewalk

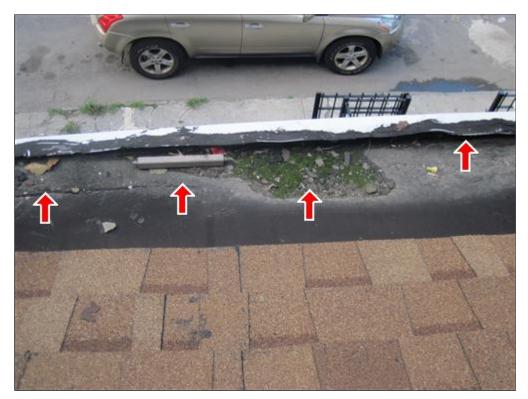
D. Picture 1 open joints/deteriorated roof

Deteriorated roof / open joints noted on lower roof at time of inspection. Repairs / replacements should be anticipated in near future. Repair as needed.(Picture 1)(Picture 2)

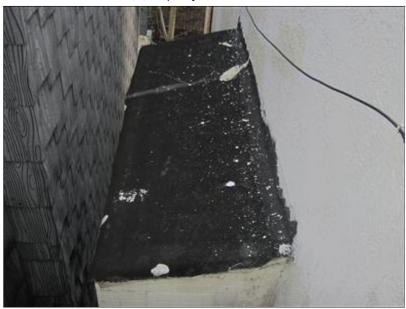
D. Picture 2 aged / deteriorated lower roof

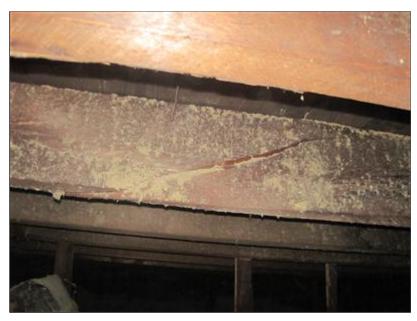
E. Picture 1 cracked rafter

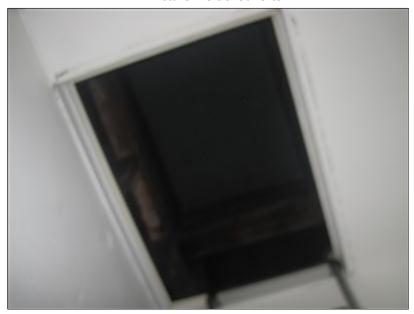
E. Picture 2 sealed roof opening
Cracked roof joist noted at time of inspection. Repair as needed.(Picture 1)(Picture 2)

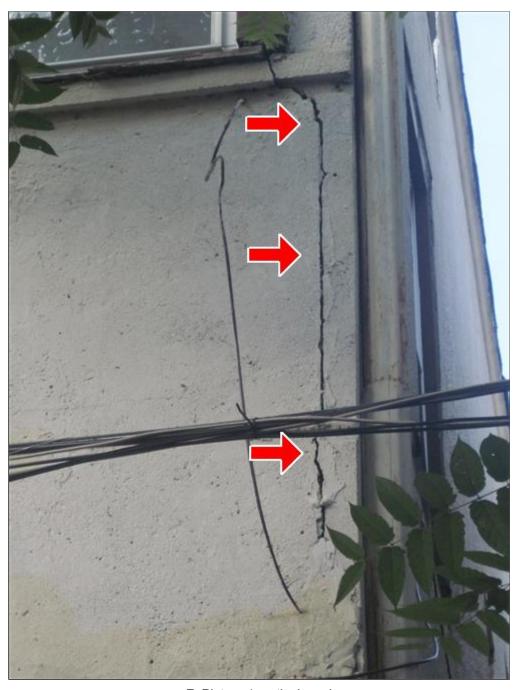
F. Picture 1 vertical crack

Significant vertical crack noted on exterior wall. Repair as needed.(Picture 1)

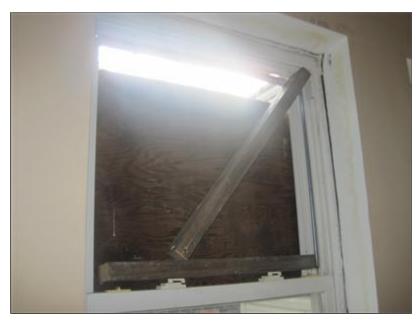
I. Picture 1 broken / missing window

Broken / covered windows noted on first floor at time of inspection. Replace as needed.(Picture 1)(Picture 2)(Picture 3)

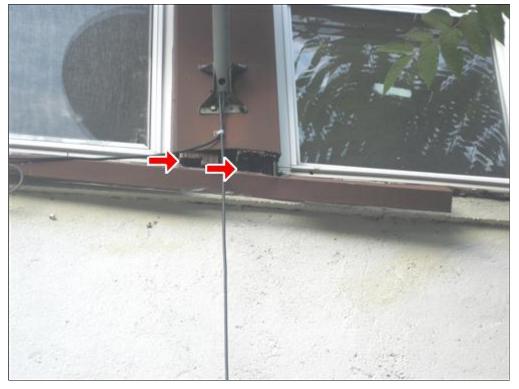
I. Picture 3 rot / damaged framing

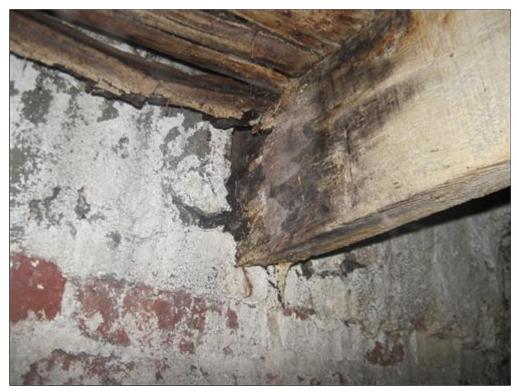
K. Picture 1 collapsing support joist

(1) Deteriorated front porch framing was noted at time of inspection. Structural repairs are required. Recommend having licensed specialist evaluate and repair as needed.(Picture 1)(Picture 2)

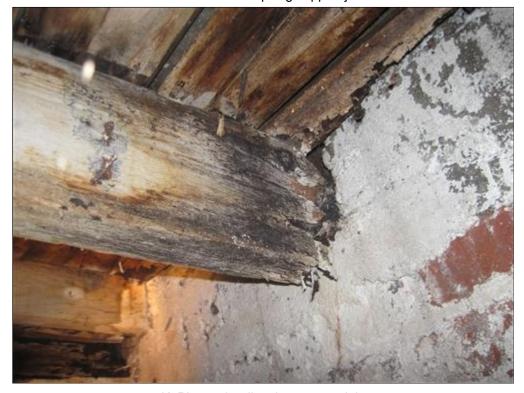
K. Picture 2 collapsing support joist

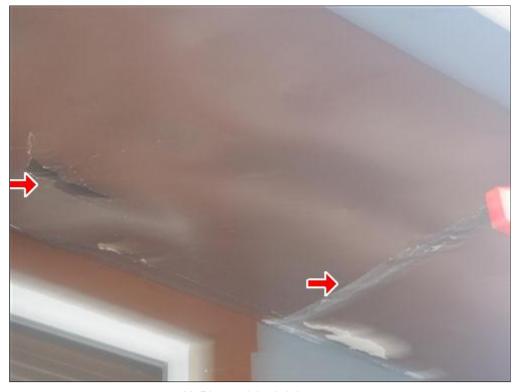
K. Picture 3 leak / damage

(2) Leaking / damaged ceiling noted on front porch at time of inspection. Repair as needed.(Picture 1)

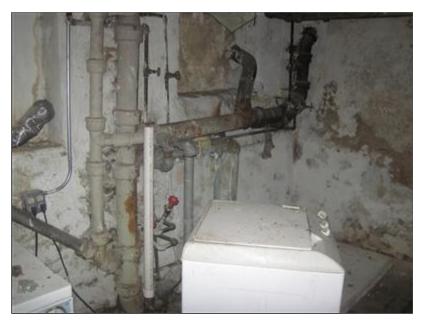
B. Picture 1 corroded / leaking drains

Significant age and wear noted on plumbing lines throughout basement. Corroded, old brass and copper supply lines and valves where noted throughout basement. Recommend having licensed plumber evaluate and repair as needed.(Picture 1)(Picture 2)(Picture 3)(Picture 4)

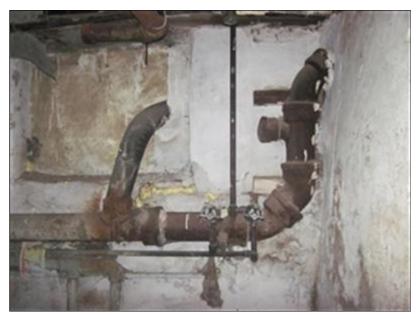
B. Picture 3 leaking / corroded drains

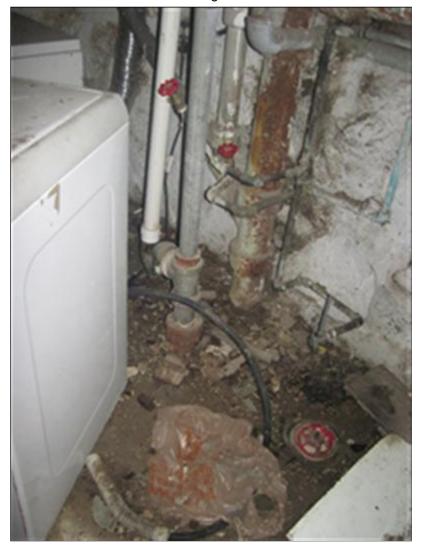
B. Picture 4 leaking corroded drains

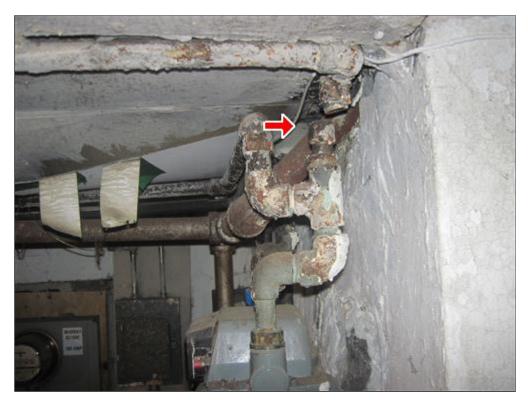
G. Picture 1 disconnected gas line/meter

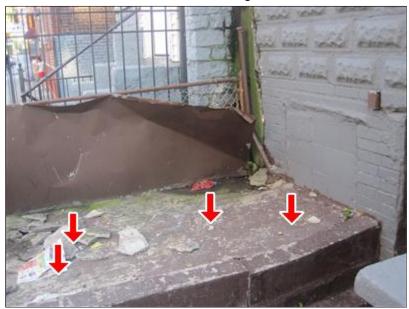
G. Picture 2 buried oil tank

(1) The oil barrel remains in ground. We did not inspect condition of barrel or soil. The area was deteriorated and condition of buried tank should be verified before closing. Repair / mitigate as needed.(Picture 1)(Picture 2)

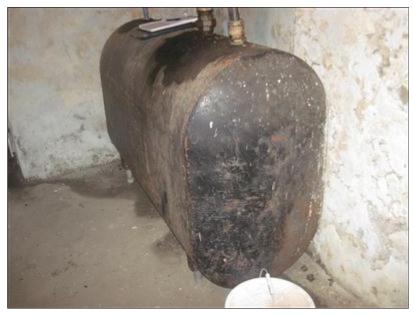
G. Picture 3 second tank in basement

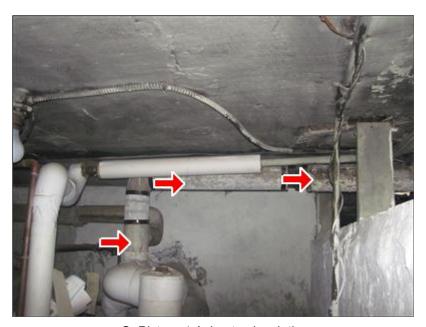
G. Picture 4 Asbestos insulation

(2) Friable asbestos pipe insulation was noted in basement at time of inspection. Properly remove and dispose of as needed. (Picture 1)
