# **Inspection Report**

Property Address: 1400 Oak Lane East Meadow NY

# **J&P Professional Property Inspections**

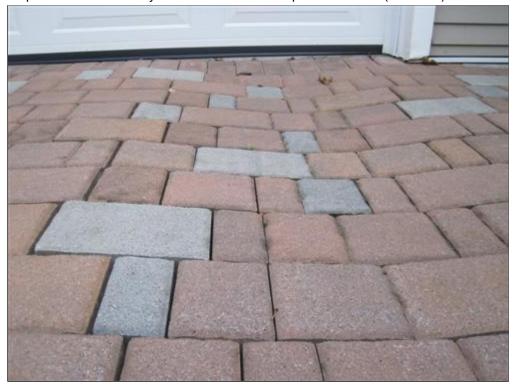
C. (1) Driveway brick pavers have unevenly settled and shifted. Repair as needed.(Picture 1)

C. Picture 1 uneven settlement

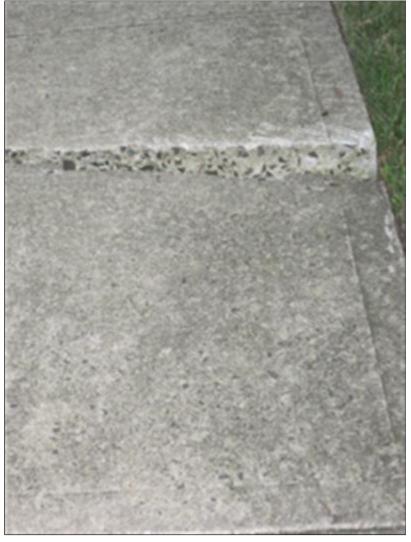
(2) Broken / cracked concrete sidewalk was noted at front of home, potential fall hazard. Repair as needed.(Picture 2)(Picture 3)

C. Picture 2 cracked sidewalk

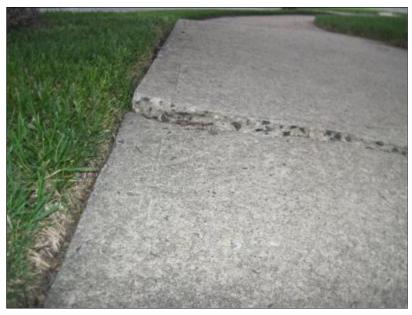
C. Picture 3 broken / cracked concrete sidewalk

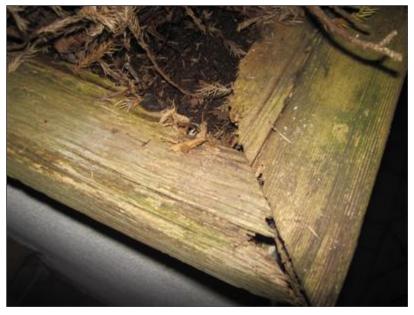
(3) Moisture damage and rot was noted on planters at front of home. Repairs should be anticipated. Repair as needed.(Picture 4)

C. Picture 4 rot damaged wood

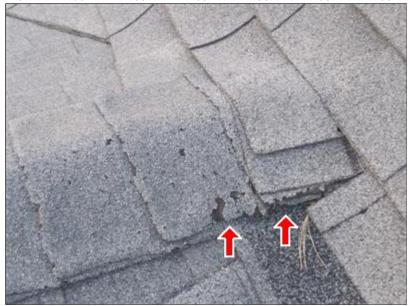
**D.** Deteriorated shingles where noted on ridge on roof at time of inspection. Repairs / replacement of various shingles should be expected in future.(Picture 1)(Picture 2)(Picture 3)(Picture 4)(Picture 5)(Picture 6)(Picture 7)(Picture 8)

D. Picture 1 crumbling shingles

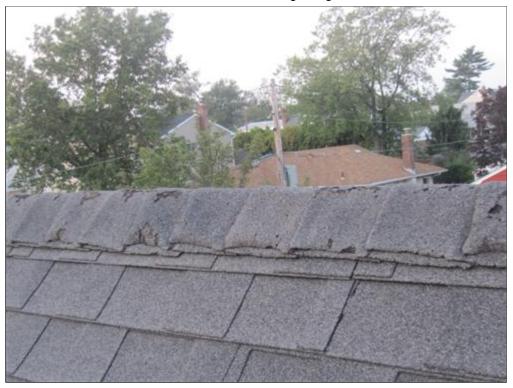
D. Picture 2 warped / crumbling shingles

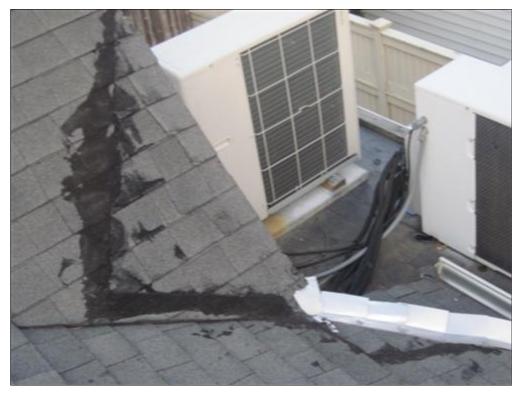
D. Picture 3 poor repair / workmanship

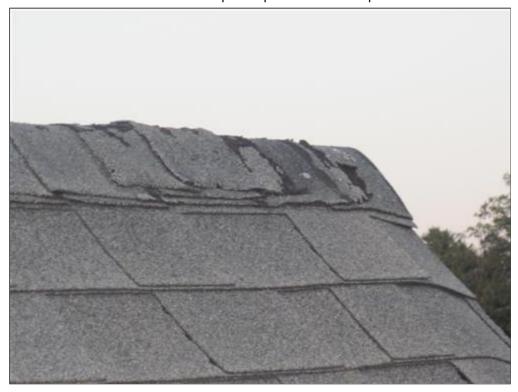
D. Picture 4 deteriorated ridge shingles

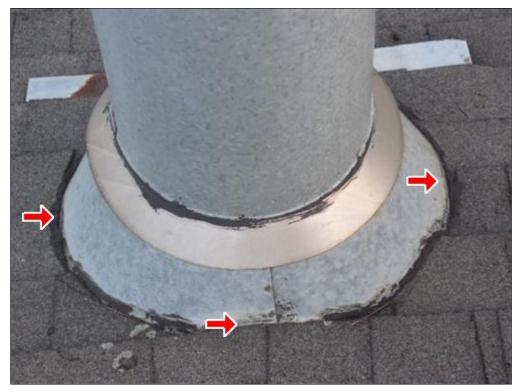
D. Picture 5 open joint / missing sealer

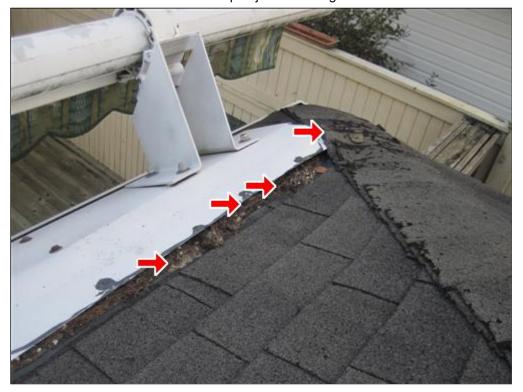
D. Picture 6 debris filled area / poor flashing

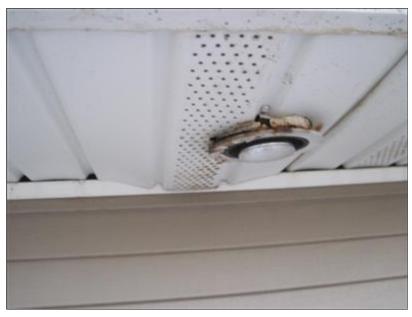
D. Picture 7 corroded light fixture from leak

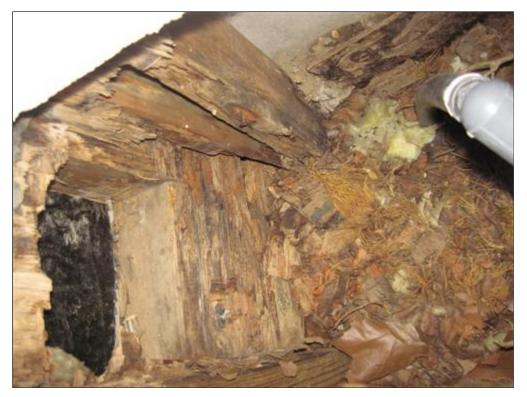
**F.** (1) Moisture damage and rot was noted on exterior wall sheathing and framing in various locations. Areas have unfinished siding leaving house wood components exposed. Recommend having licensed specialist further evaluate and verify extent amount of damage before repairing.(Picture 1)(Picture 2)(Picture 3)

F. Picture 1 rot damage

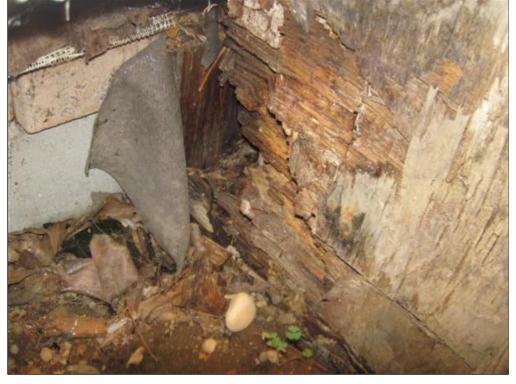
F. Picture 2 rot damage wood framing

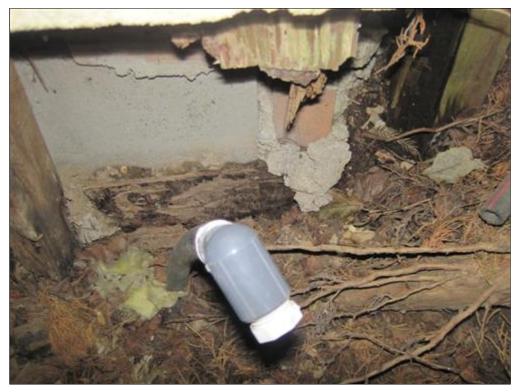
F. Picture 3 rot damage

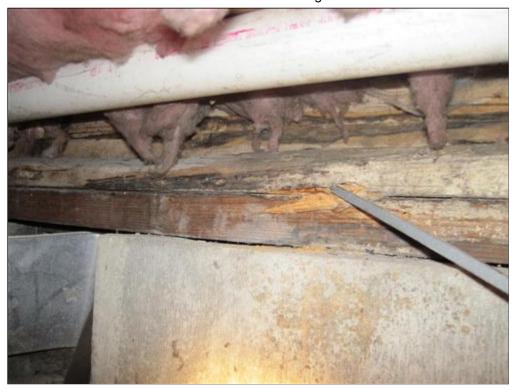
Moisture and termite damaged mud sill was noted in crawlspace under living room / kitchen area. Framing needs to be repaired and treated in near future. Recommend having licensed specialist repair as needed.(Picture 4)(Picture 5)(Picture 6)(Picture 7)(Picture 8)

F. Picture 4 damaged sill

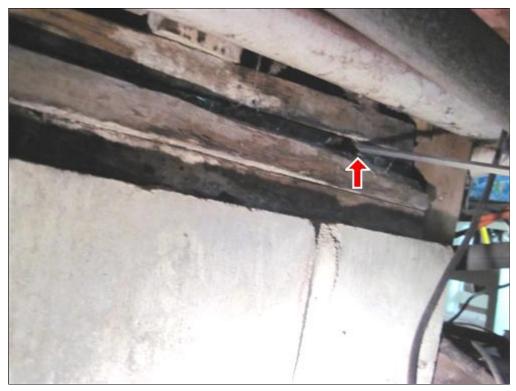
F. Picture 5 damaged sill

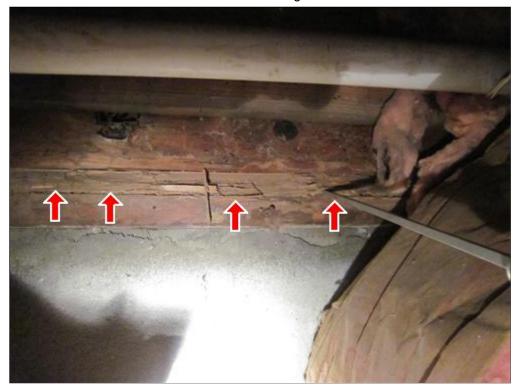
F. Picture 6 termite infestation / damage

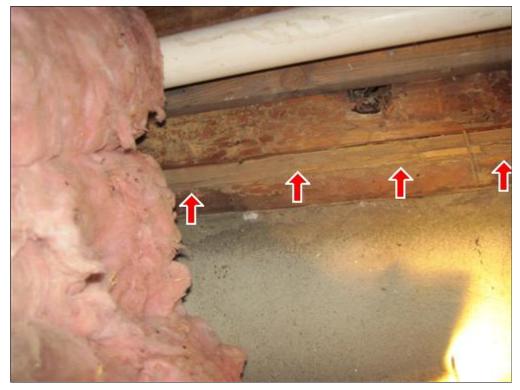
F. Picture 7 termite damage

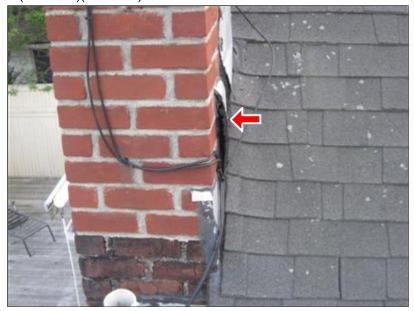
**J.** Open joints, poorly installed chimney flashing was noted on roof at time of inspection. Repairs / periodic maintenance should be expected in future.(Picture 1)(Picture 2)

J. Picture 1 open joints

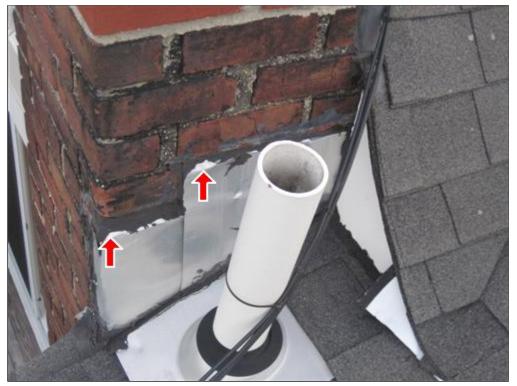
J. Picture 2 poor sealing / workmanship

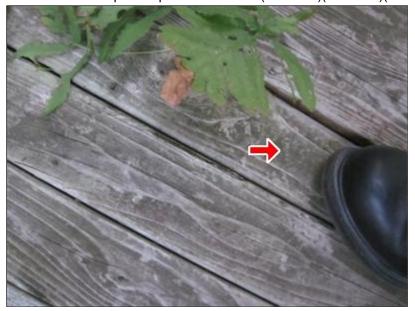
**K.** (1) Moisture damaged / rot wood deck boards was noted throughout rear of home. Repairs / replacement of numerous boards should be expected in near future. Repair / replace as needed.(Picture 1)(Picture 2)(Picture 3)(Picture 4)

K. Picture 1 collapsing board

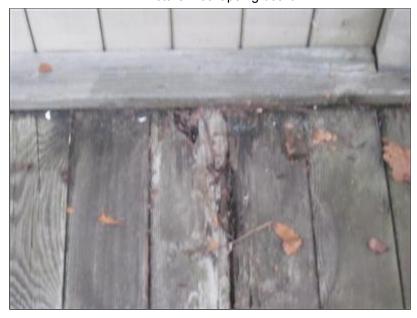
K. Picture 2 rot damage

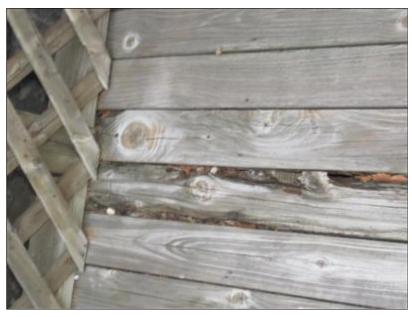
K. Picture 3 rot damage

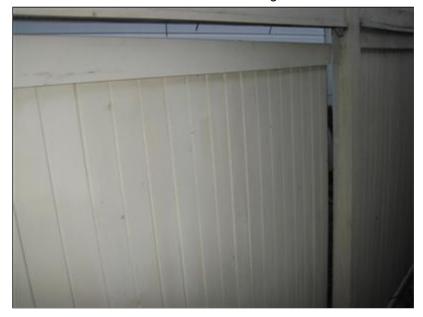
K. Picture 4 detached panel

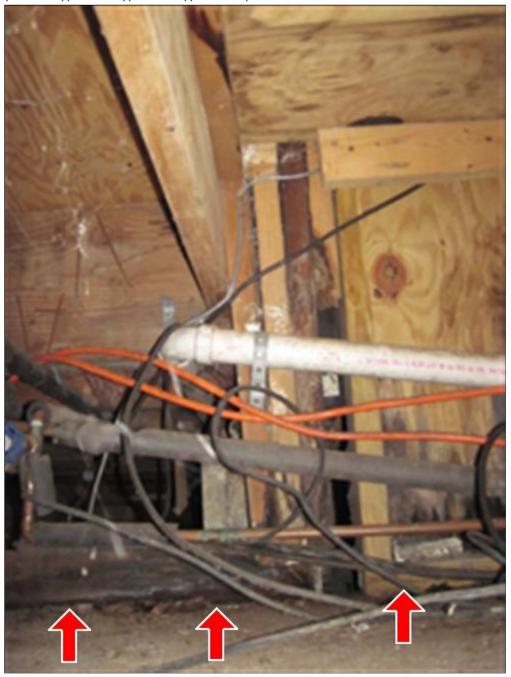
(2) Moisture entry and rot damage was noted on wood components and sill plate through garage crawlspace, underneath kitchen area. Recommend having licensed specialist further evaluate and confirm extent of damage before repairing. Repair as needed.(Picture 5)(Picture 6)(Picture 8)

K. Picture 5 water entry / damage

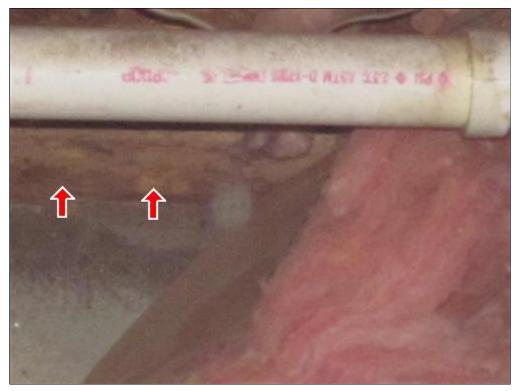
K. Picture 6 possible water damage at end of crawl space

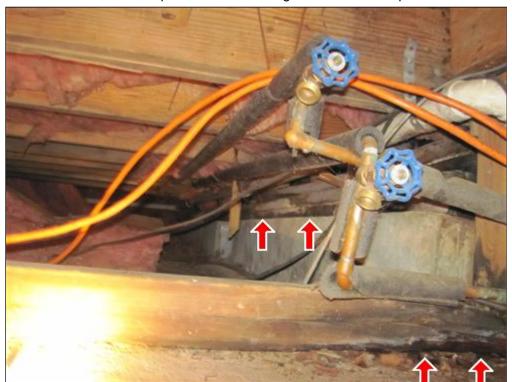
K. Picture 7 rot damage / moisture stains

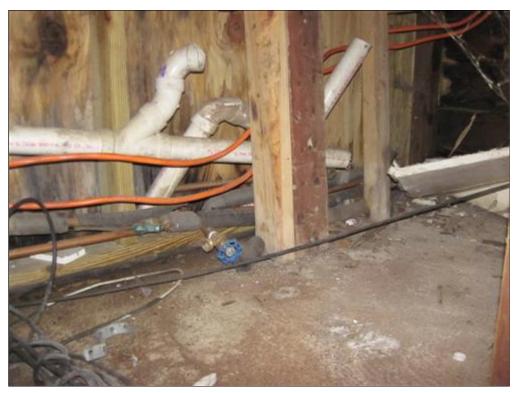
K. Picture 8 moisture entry, abandoned drains, rot

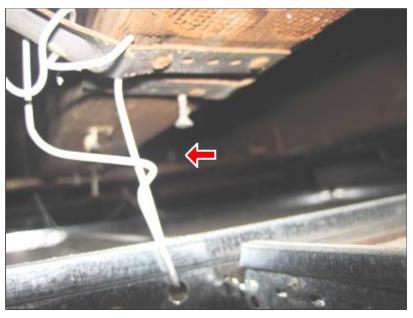
A. Corrosion / minor leaks was noted on lower floor above drop ceiling at time of inspection. Repair as needed.(Picture 1)(Picture 2)(Picture 3)

A. Picture 1 corroded fittings

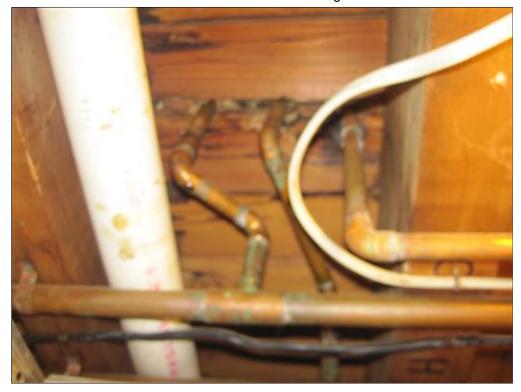
A. Picture 2 possible leaks

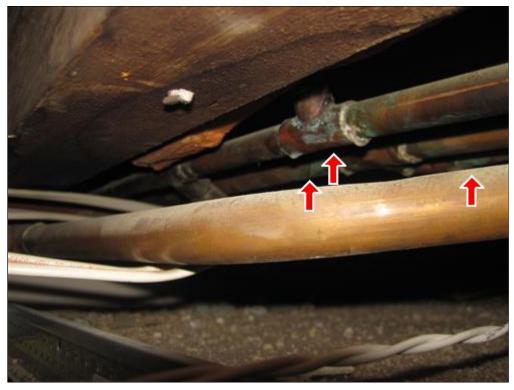
A. Picture 3 possible leaks

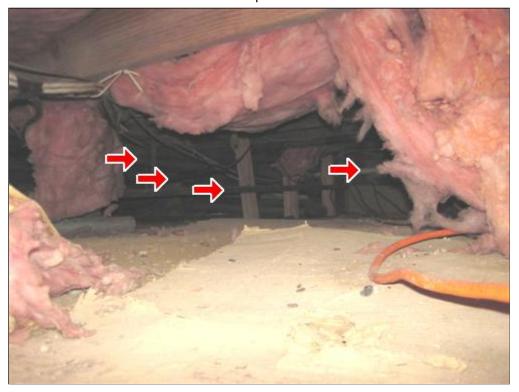
1400 Oak Lane Page 27 of 56 Poorly insulated and protected plumbing lines noted in crawl space under kitchen at time of inspection. Supply lines can possibly freeze and burst. Recommend insulating as needed.(Picture 4)

A. Picture 4 un-insulated plumbing lines

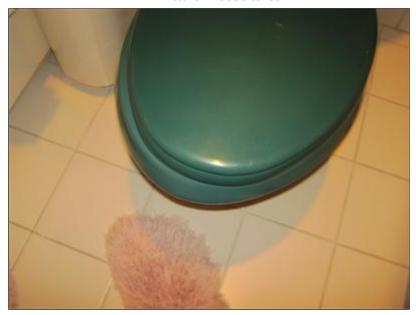
**B.** The are two toilets that are loose at floor at the hall baths. Repairs are needed. A qualified licensed plumber should repair or correct as needed.(Picture 1)(Picture 2)

B. Picture 2 loose toilet

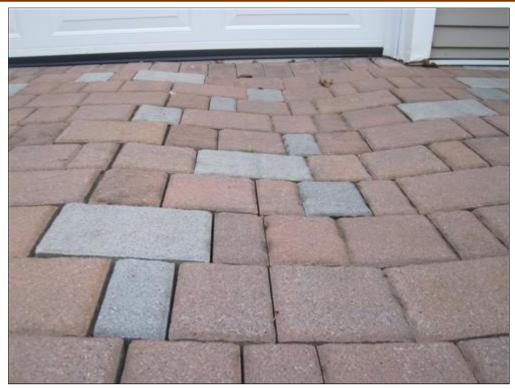
(1) Driveway brick pavers have unevenly settled and shifted. Repair as needed.(Picture 1)

C. Picture 1 uneven settlement

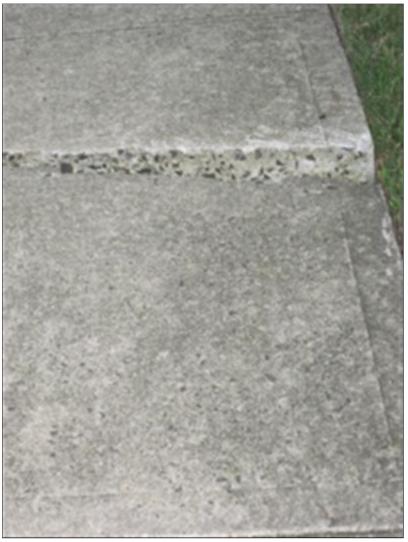
(2) Broken / cracked concrete sidewalk was noted at front of home, potential fall hazard. Repair as needed.(Picture 2)(Picture 3)

C. Picture 2 cracked sidewalk

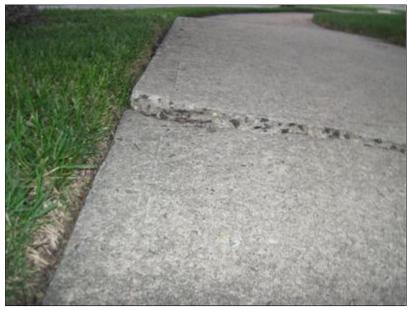
C. Picture 3 broken / cracked concrete sidewalk

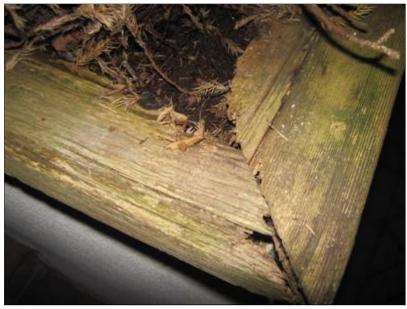
(3) Moisture damage and rot was noted on planters at front of home. Repairs should be anticipated. Repair as needed.(Picture 4)

C. Picture 4 rot damaged wood

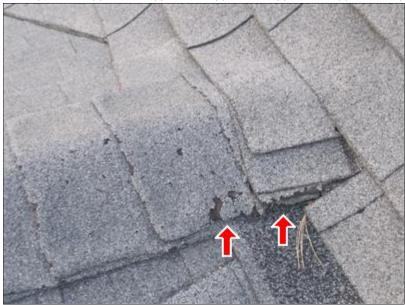
Deteriorated shingles where noted on ridge on roof at time of inspection. Repairs / replacement of various shingles should be expected in future.(Picture 1)(Picture 2)(Picture 3)(Picture 4)(Picture 5)(Picture 6)(Picture 7)(Picture 8)

D. Picture 1 crumbling shingles

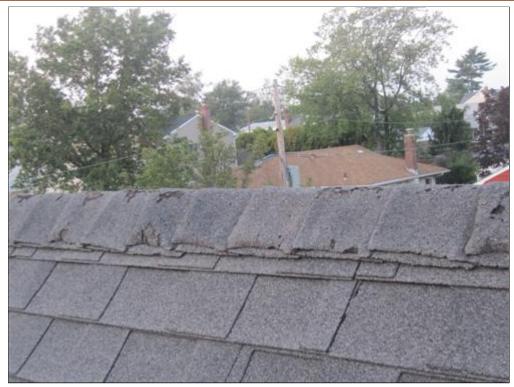
D. Picture 2 warped / crumbling shingles

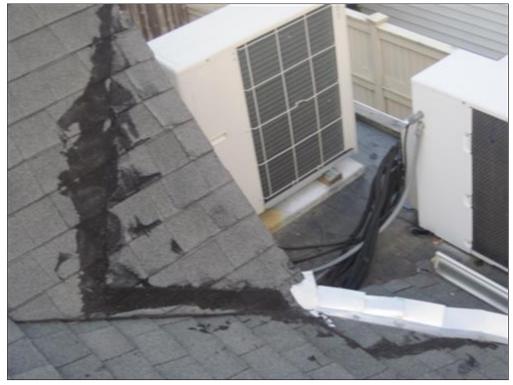
D. Picture 3 poor repair / workmanship

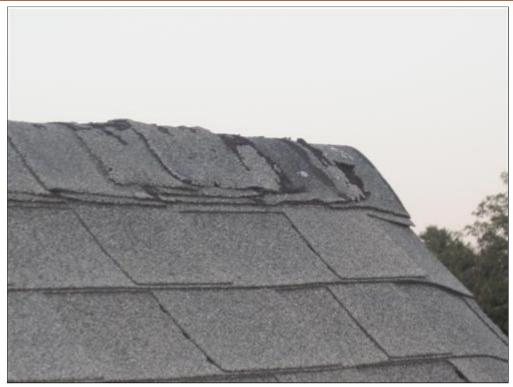
D. Picture 4 deteriorated ridge shingles

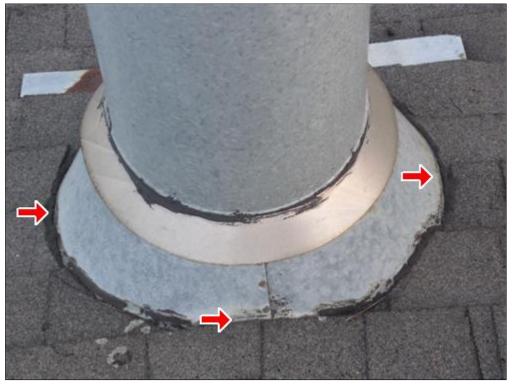
D. Picture 5 open joint / missing sealer

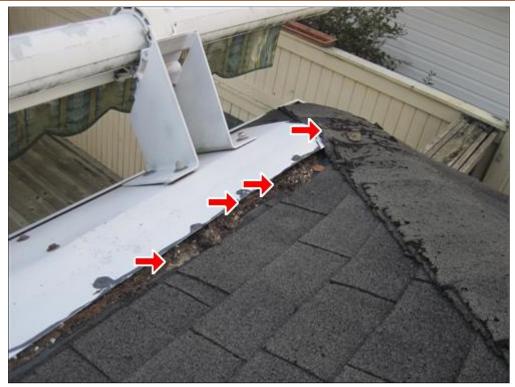
D. Picture 6 debris filled area / poor flashing

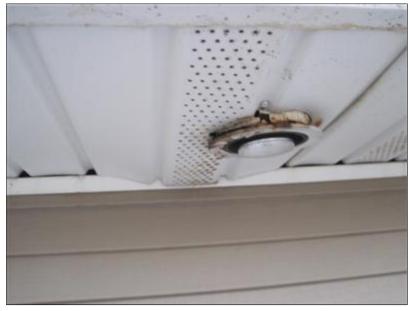
D. Picture 7 corroded light fixture from leak

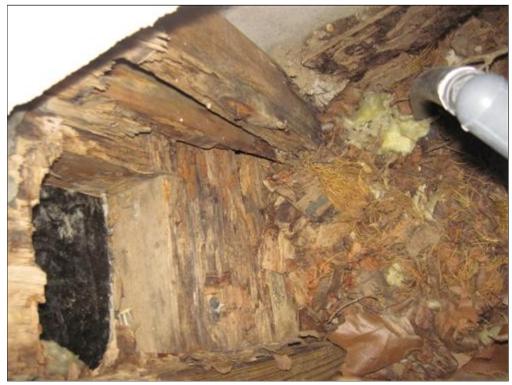
(1) Moisture damage and rot was noted on exterior wall sheathing and framing in various locations. Areas have unfinished siding leaving house wood components exposed. Recommend having licensed specialist further evaluate and verify extent amount of damage before repairing.(Picture 1)(Picture 2)(Picture 3)

F. Picture 1 rot damage

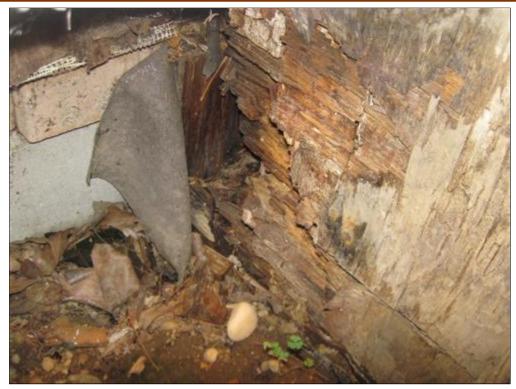
F. Picture 2 rot damage wood framing

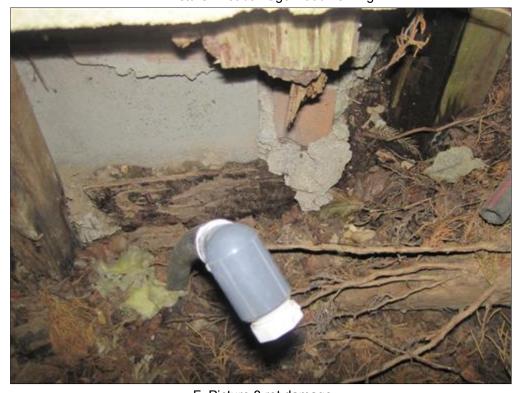
F. Picture 3 rot damage

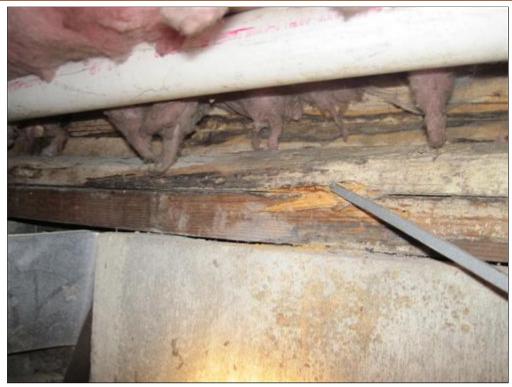
Moisture and termite damaged mud sill was noted in crawlspace under living room / kitchen area. Framing needs to be repaired and treated in near future. Recommend having licensed specialist repair as needed.(Picture 4)(Picture 5)(Picture 6)(Picture 7)(Picture 8)

F. Picture 4 damaged sill

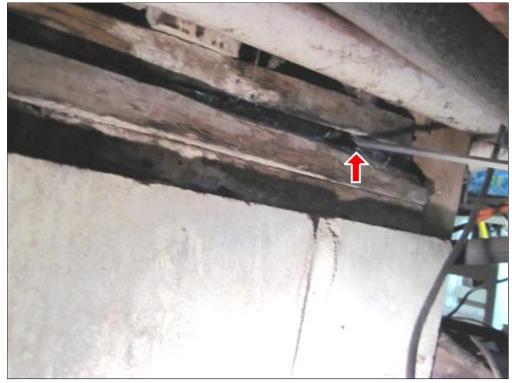
F. Picture 5 damaged sill

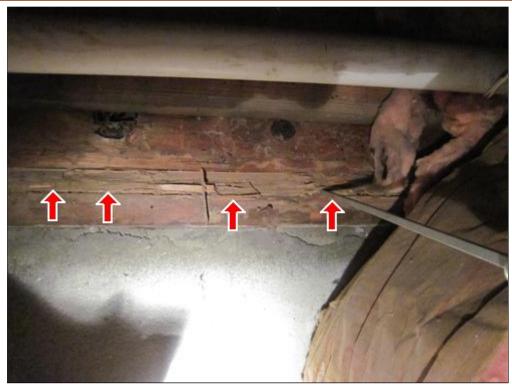
F. Picture 6 termite infestation / damage

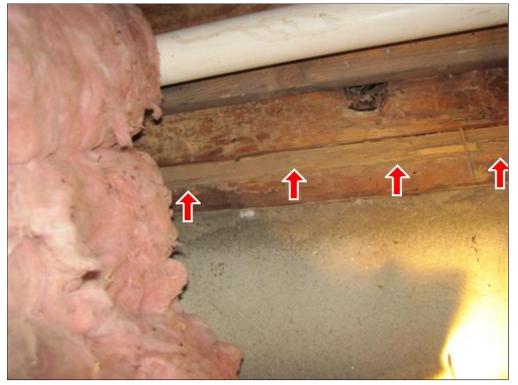
F. Picture 7 termite damage

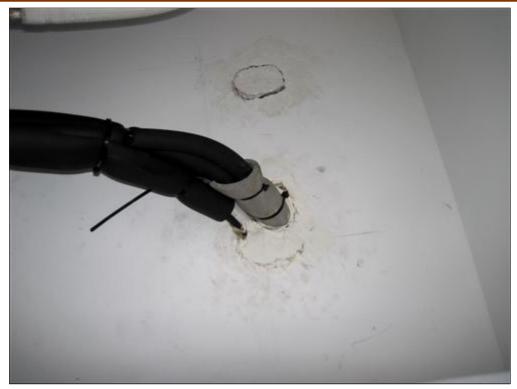
The Plaster on the ceiling reveals a light stain which appears from a water leak. Stain appears old at the closet. While this damage is cosmetic, the repair cost should be considered due to the amount of damage. A qualified person should repair or replace as needed. (Picture 1) (Picture 2)

G. Picture 1 moisture leak

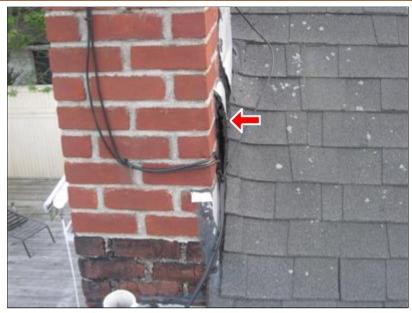
Open joints, poorly installed chimney flashing was noted on roof at time of inspection. Repairs / periodic maintenance should be expected in future.(Picture 1)(Picture 2)

J. Picture 1 open joints

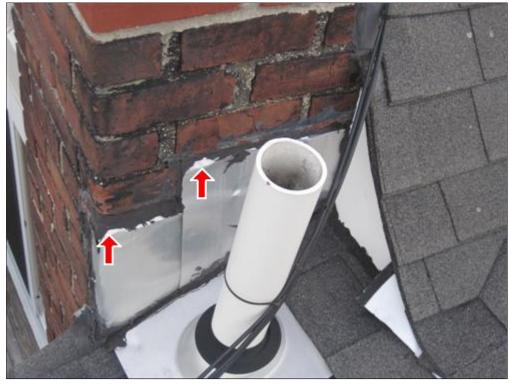
J. Picture 2 poor sealing / workmanship

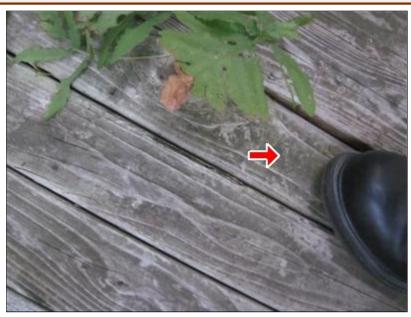
(1) Moisture damaged / rot wood deck boards was noted throughout rear of home. Repairs / replacement of numerous boards should be expected in near future. Repair / replace as needed.(Picture 1)(Picture 2)(Picture 3)(Picture 4)

K. Picture 1 collapsing board

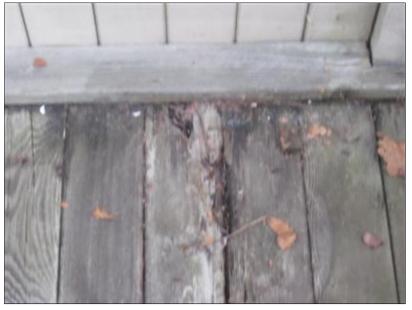
K. Picture 2 rot damage

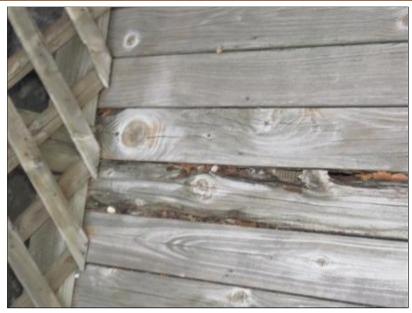
K. Picture 3 rot damage

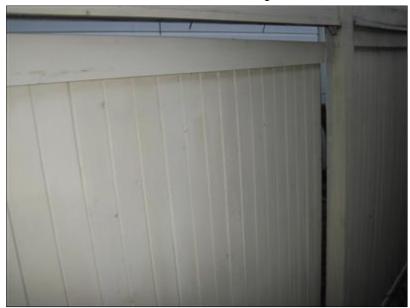
K. Picture 4 detached panel

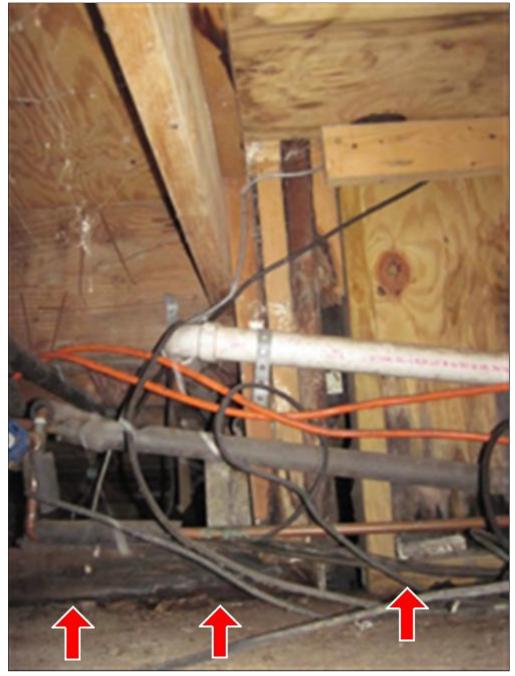
(2) Moisture entry and rot damage was noted on wood components and sill plate through garage crawlspace, underneath kitchen area. Recommend having licensed specialist further evaluate and confirm extent of damage before repairing. Repair as needed.(Picture 5)(Picture 6)(Picture 8)

K. Picture 5 water entry / damage

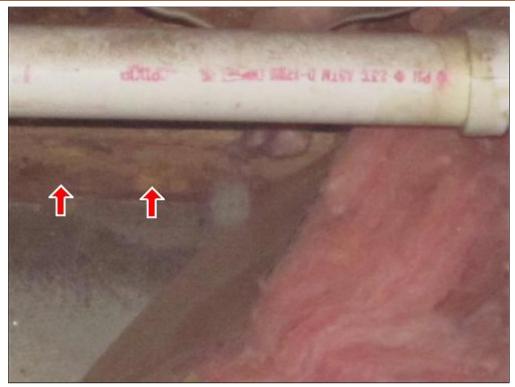
K. Picture 6 possible water damage at end of crawl space

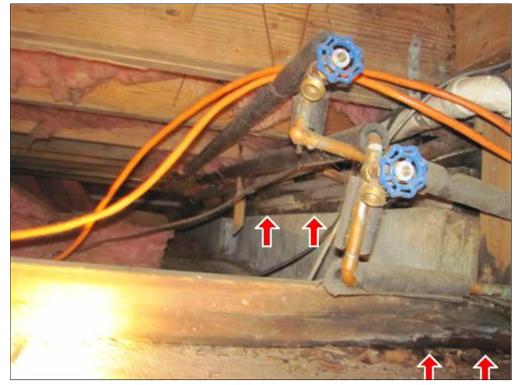
K. Picture 7 rot damage / moisture stains

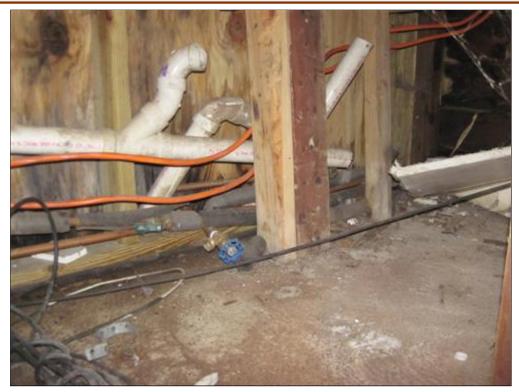
K. Picture 8 moisture entry, abandoned drains, rot

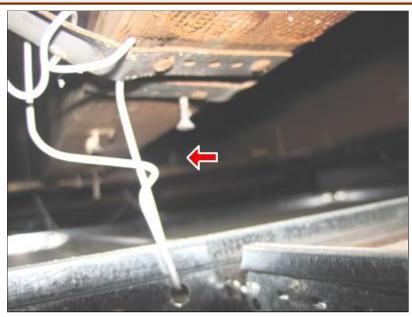
Corrosion / minor leaks was noted on lower floor above drop ceiling at time of inspection. Repair as needed.(Picture 1)(Picture 2)(Picture 3)

A. Picture 1 corroded fittings

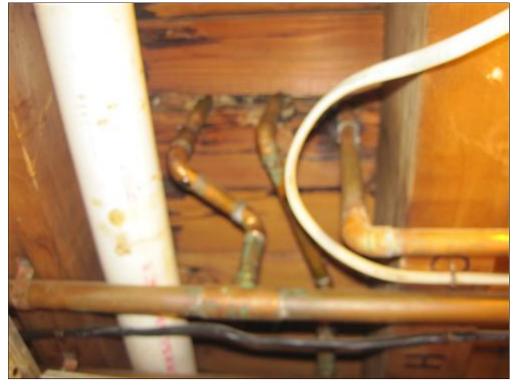
A. Picture 2 possible leaks

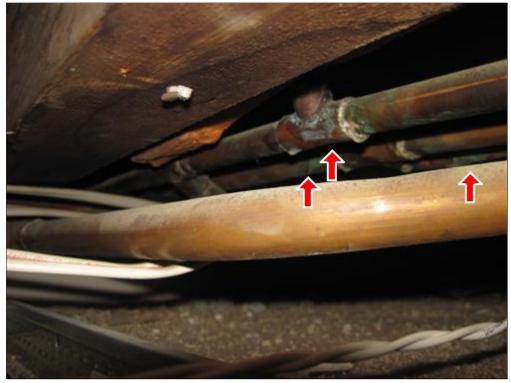
A. Picture 3 possible leaks

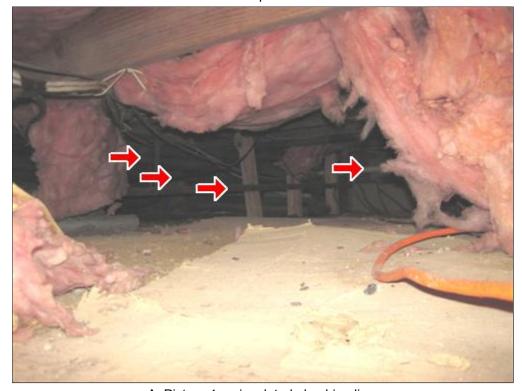
Poorly insulated and protected plumbing lines noted in crawl space under kitchen at time of inspection. Supply lines can possibly freeze and burst. Recommend insulating as needed.(Picture 4)

A. Picture 4 un-insulated plumbing lines

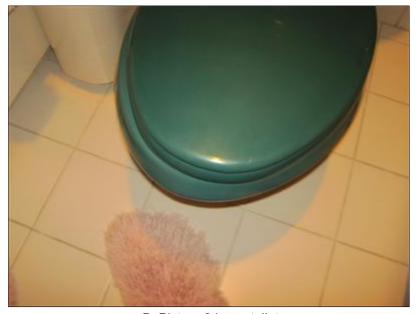
The are two toilets that are loose at floor at the hall baths. Repairs are needed. A qualified licensed plumber should repair or correct as needed. (Picture 1) (Picture 2)

B. Picture 2 loose toilet
