Inspection Report

J&P Professional Property Inspections

35 Oakfield Avenue Freeport, NY 11520

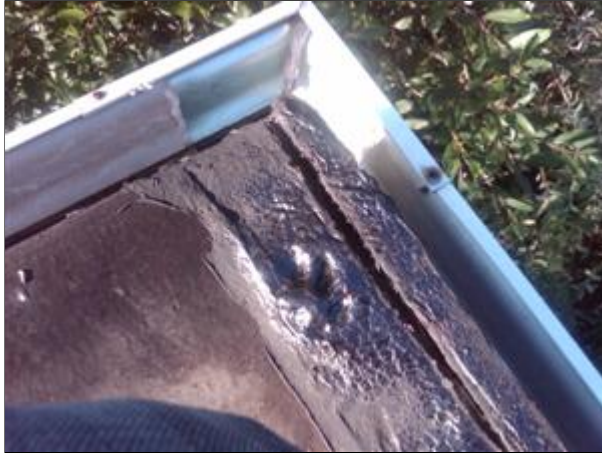
Open joint at roof level

**1.1** Open Joints, bubbles noted on rubber roof. No leaks noted at time of inspection, however, general repairs should be anticipated in future. In addition, recommend applying aluminum paint to extend life. Repair as needed.
-

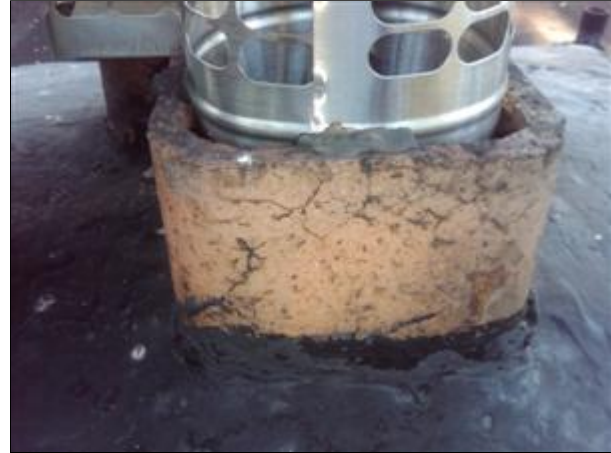
Flue

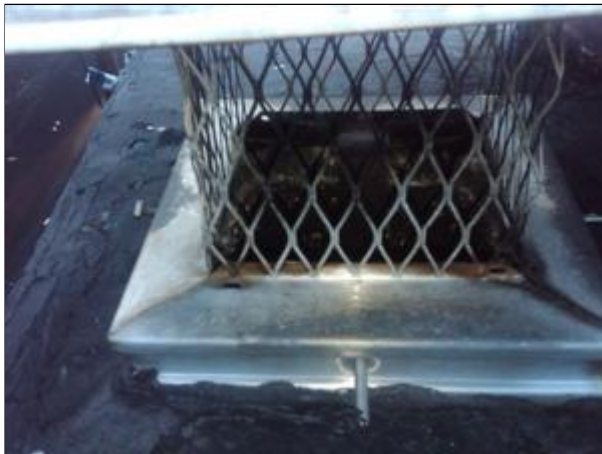
Age and wear noted on flue

**1.2** Chimney flue's had evidence of age and wear. Crack and creosote noted and should be checked by licensed specialist. Repair and clean as needed.
-

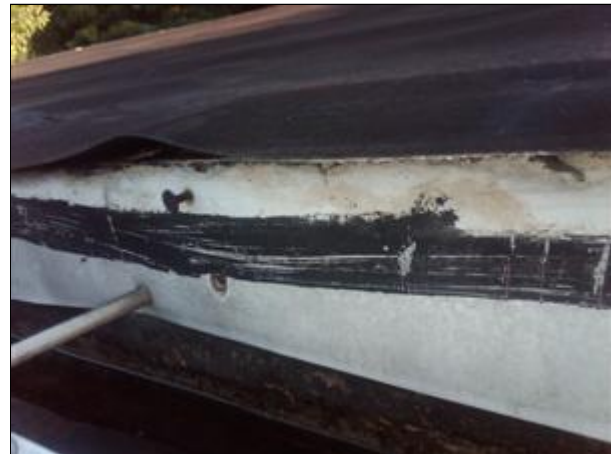
Open joint at edge

**1.0** Bubbled areas, open joints noted above garage. General repairs should be anticipated in future. No leaks witnessed at time of inspection. Recommend applying aluminum paint to extend life expectancy. Repair as needed.
-

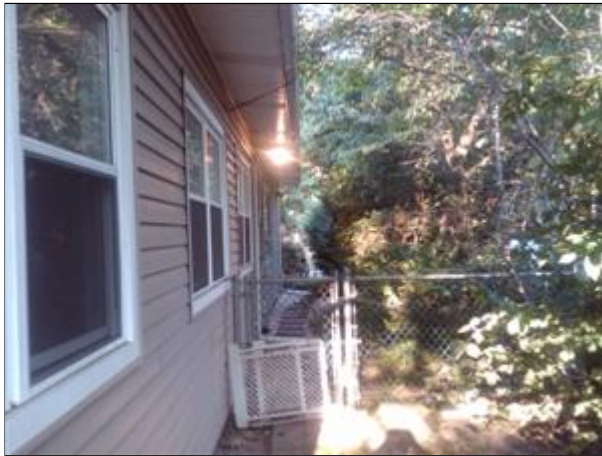
Excess vegetation and shrubbery

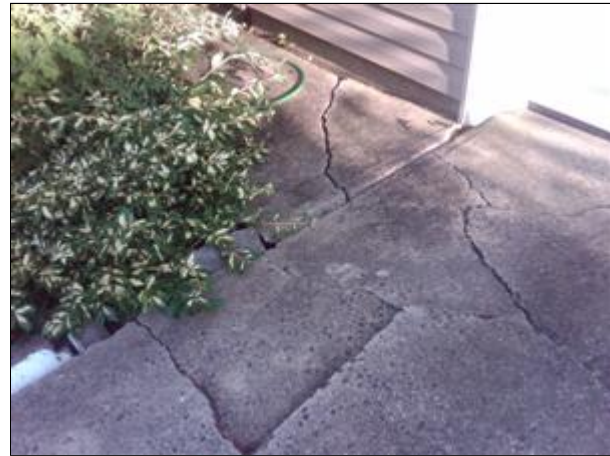
Broken Concrete

(2) Concrete walkways and driveways had cracked and broken areas. Repair and / or replacements should be anticipated in the near future. Significant trip hazard noted at front of home. Repair ASAP.

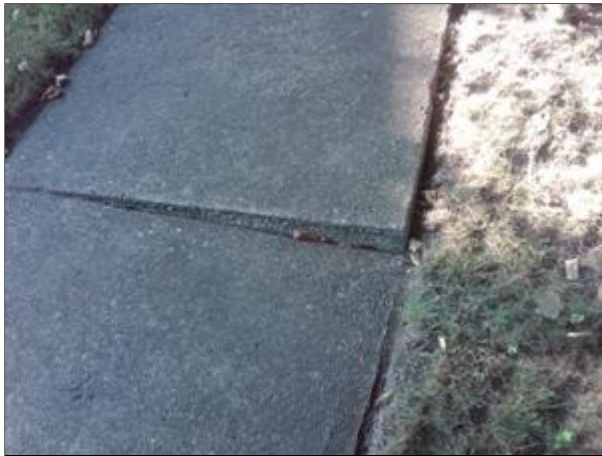
Typical Trip hazards

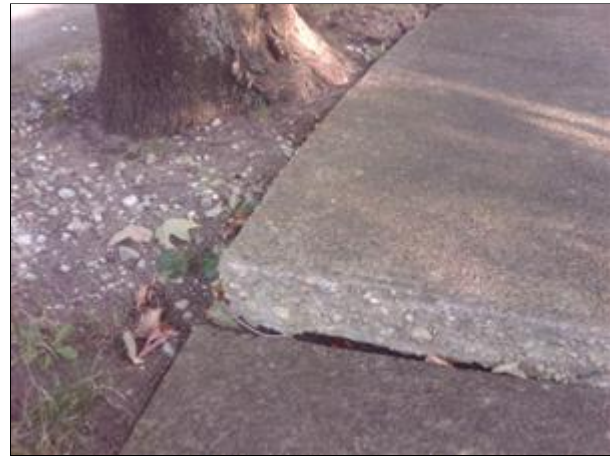
Typical Trip Hazard

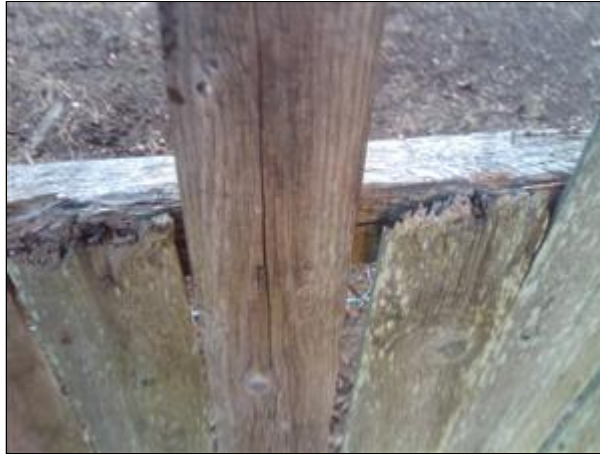
Wood Picket Fence

2.6 Dilapidated, termite damaged wood picket fence noted at rear of home. Replace as needed.

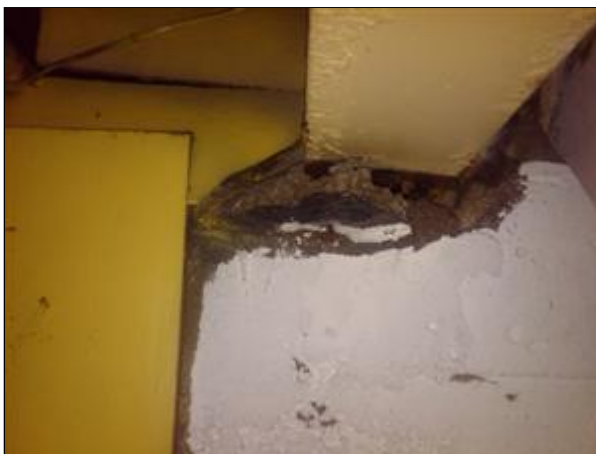
Repair Shims under Beam

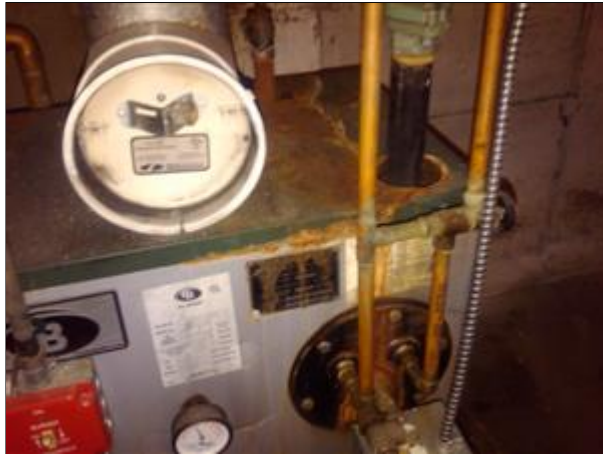
Aged Boiler

**4.0** Significant age, wear and corrosion noted on heating unit. Repair and/or replacement should be anticipated in near future. Recommend having licensed specialist evaluate and repair / replace as needed.

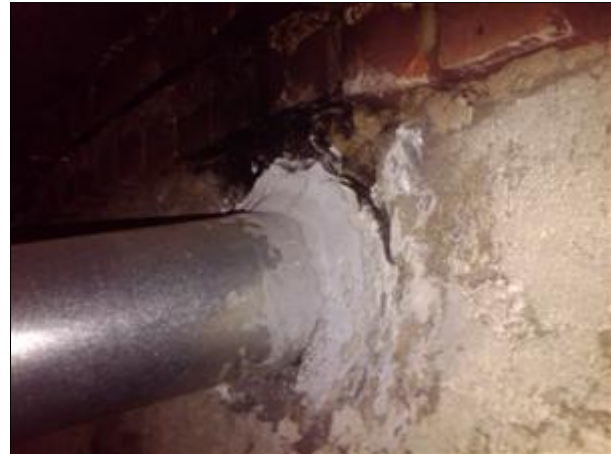
Open joint

**4.5** Chimney liners / flue had creosote build up and cracks / deterioration. Recommend having licensed chimney specialist evaluate and repair / replace as needed. Open joint noted on boiler flue into chimney. Repair as needed.

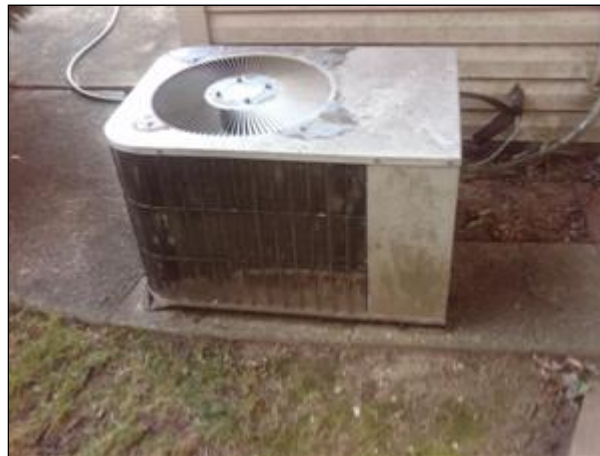
Aged unit

**4.6** The condenser outside (AC unit) is very old and may last a few years more, but maybe not. I have seen units fail shortly after a home inspection during the seasonal change from mild to hot weather. I cannot determine how long your AC will last before a replacement is necessary.
